River Mile 10.9 Removal Action – Steep Sloped Areas

PREPARED FOR: de maximis, inc.
COPY TO: File
PREPARED BY: CH2M HILL
DATE: September 26, 2013
PROJECT NUMBER: 474468.RA.PM.01

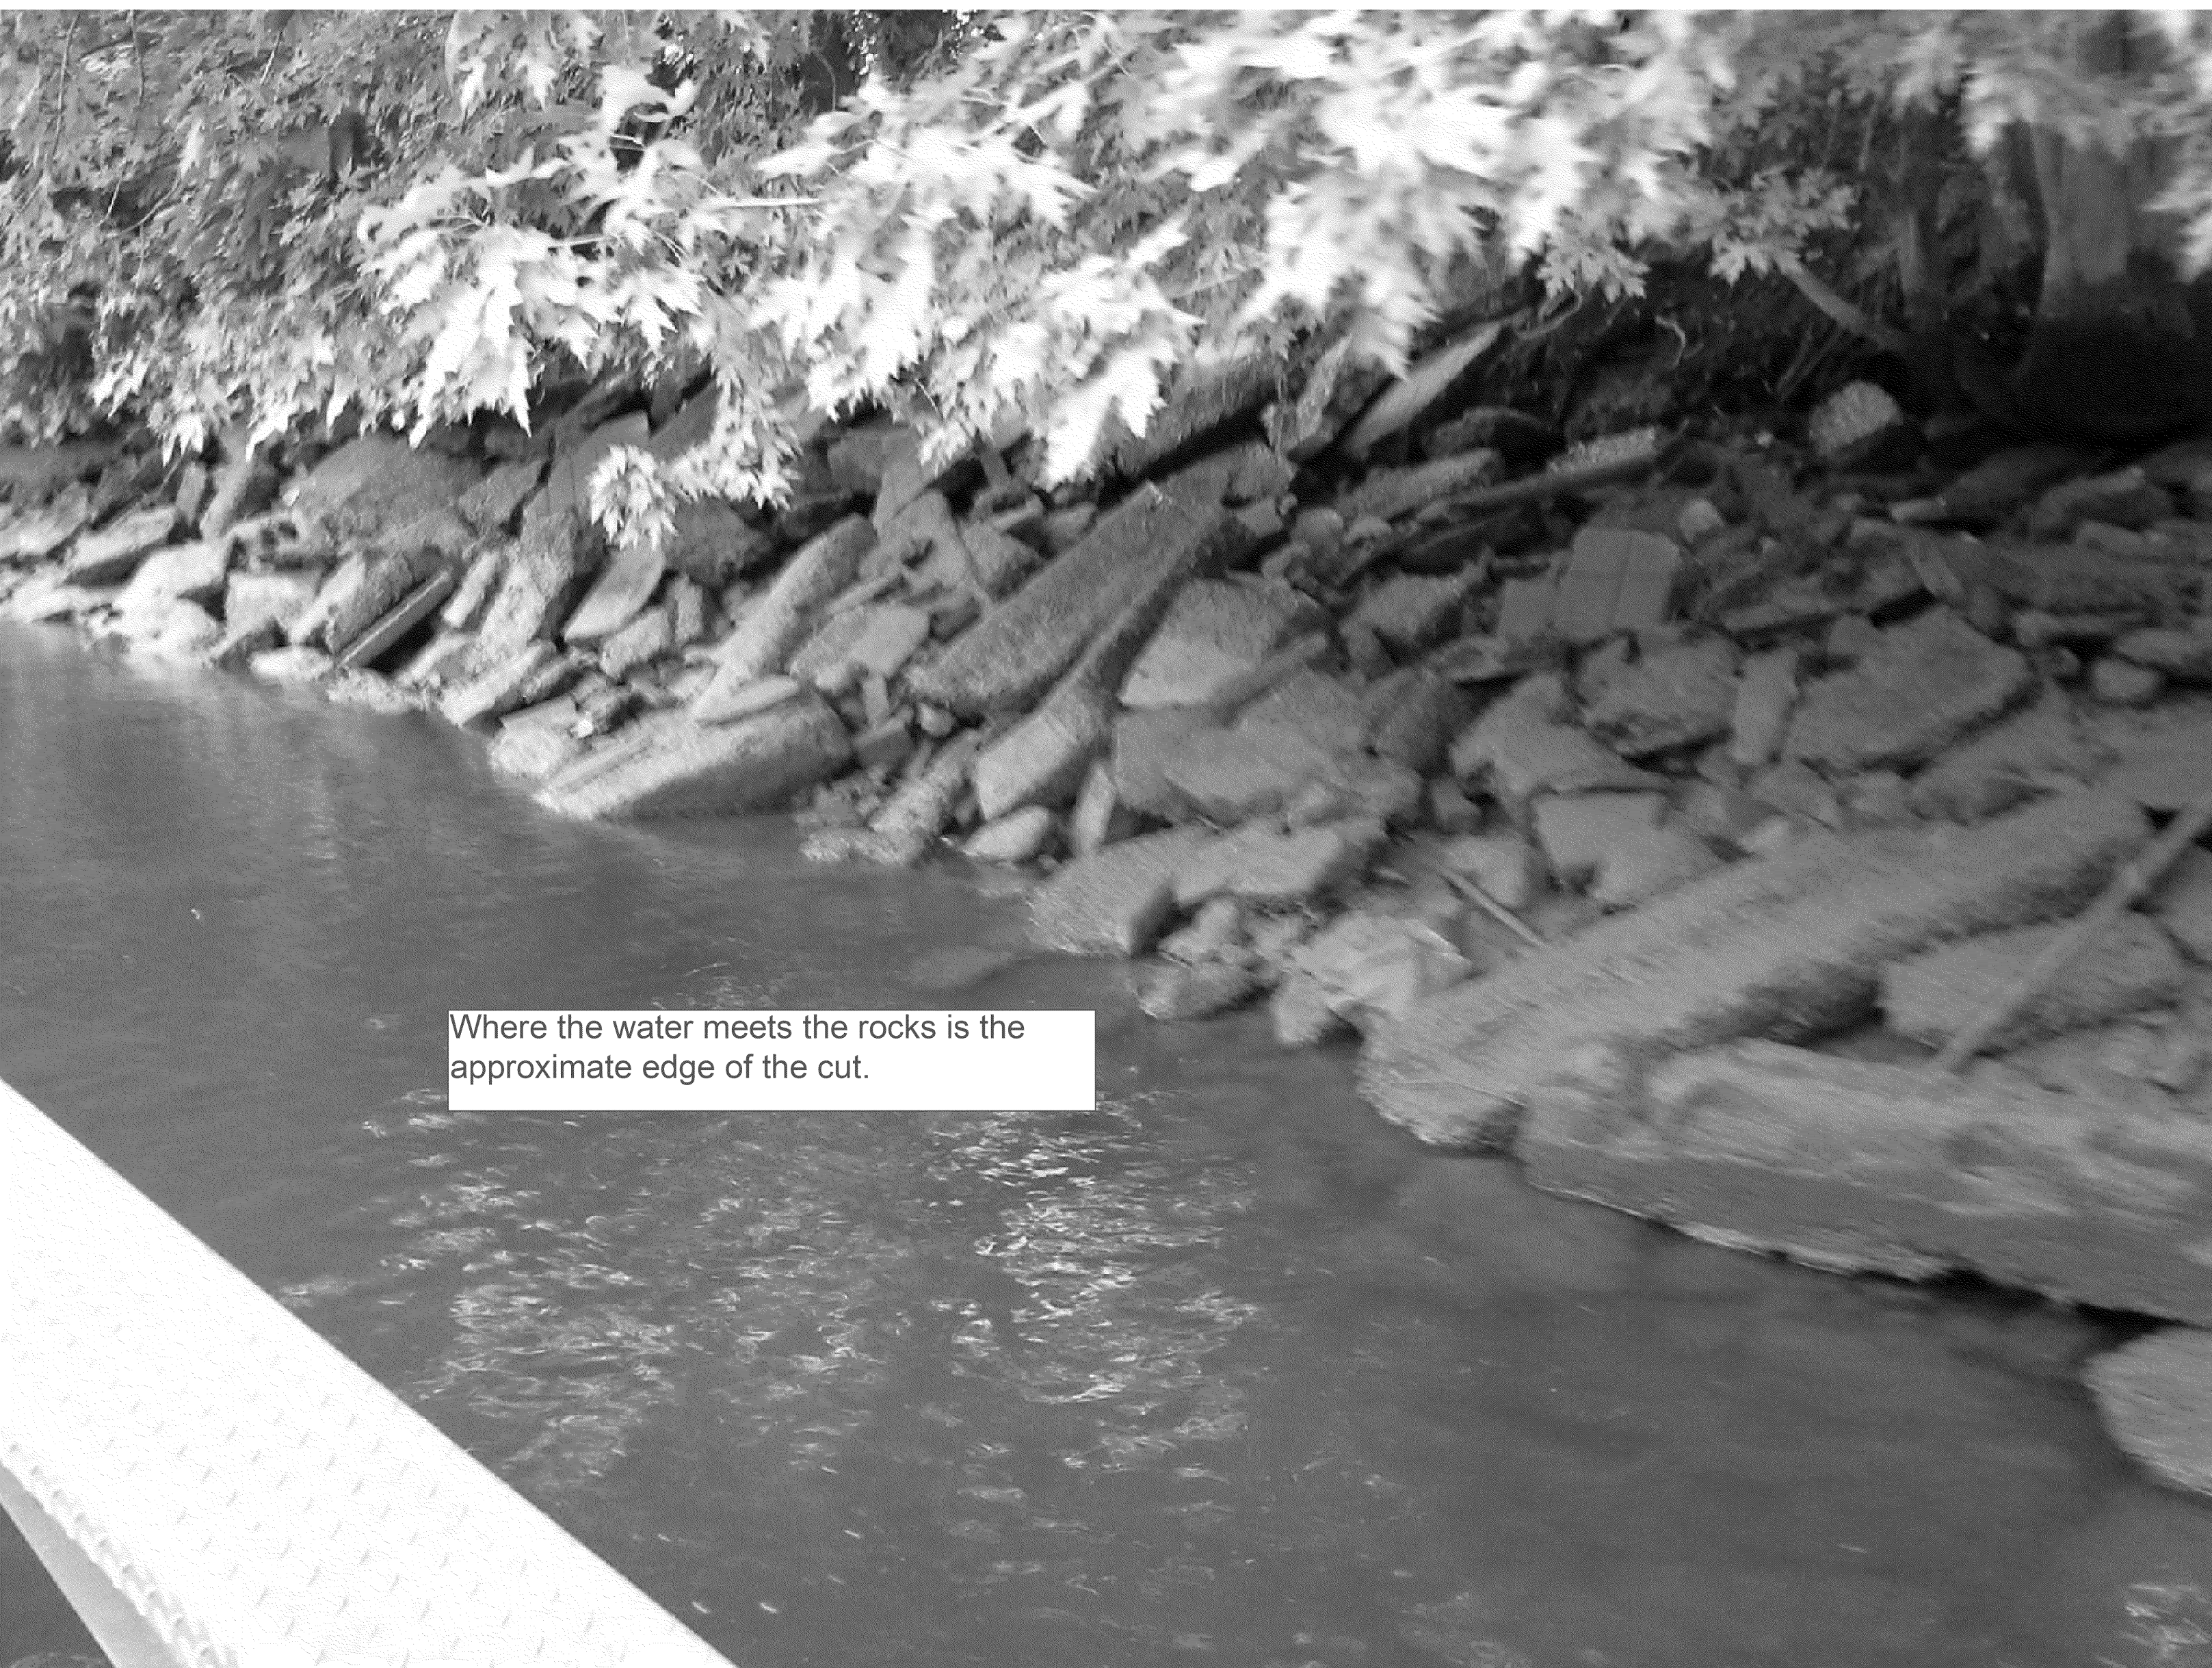
Where the water meets the rocks is the approximate edge of the cut.

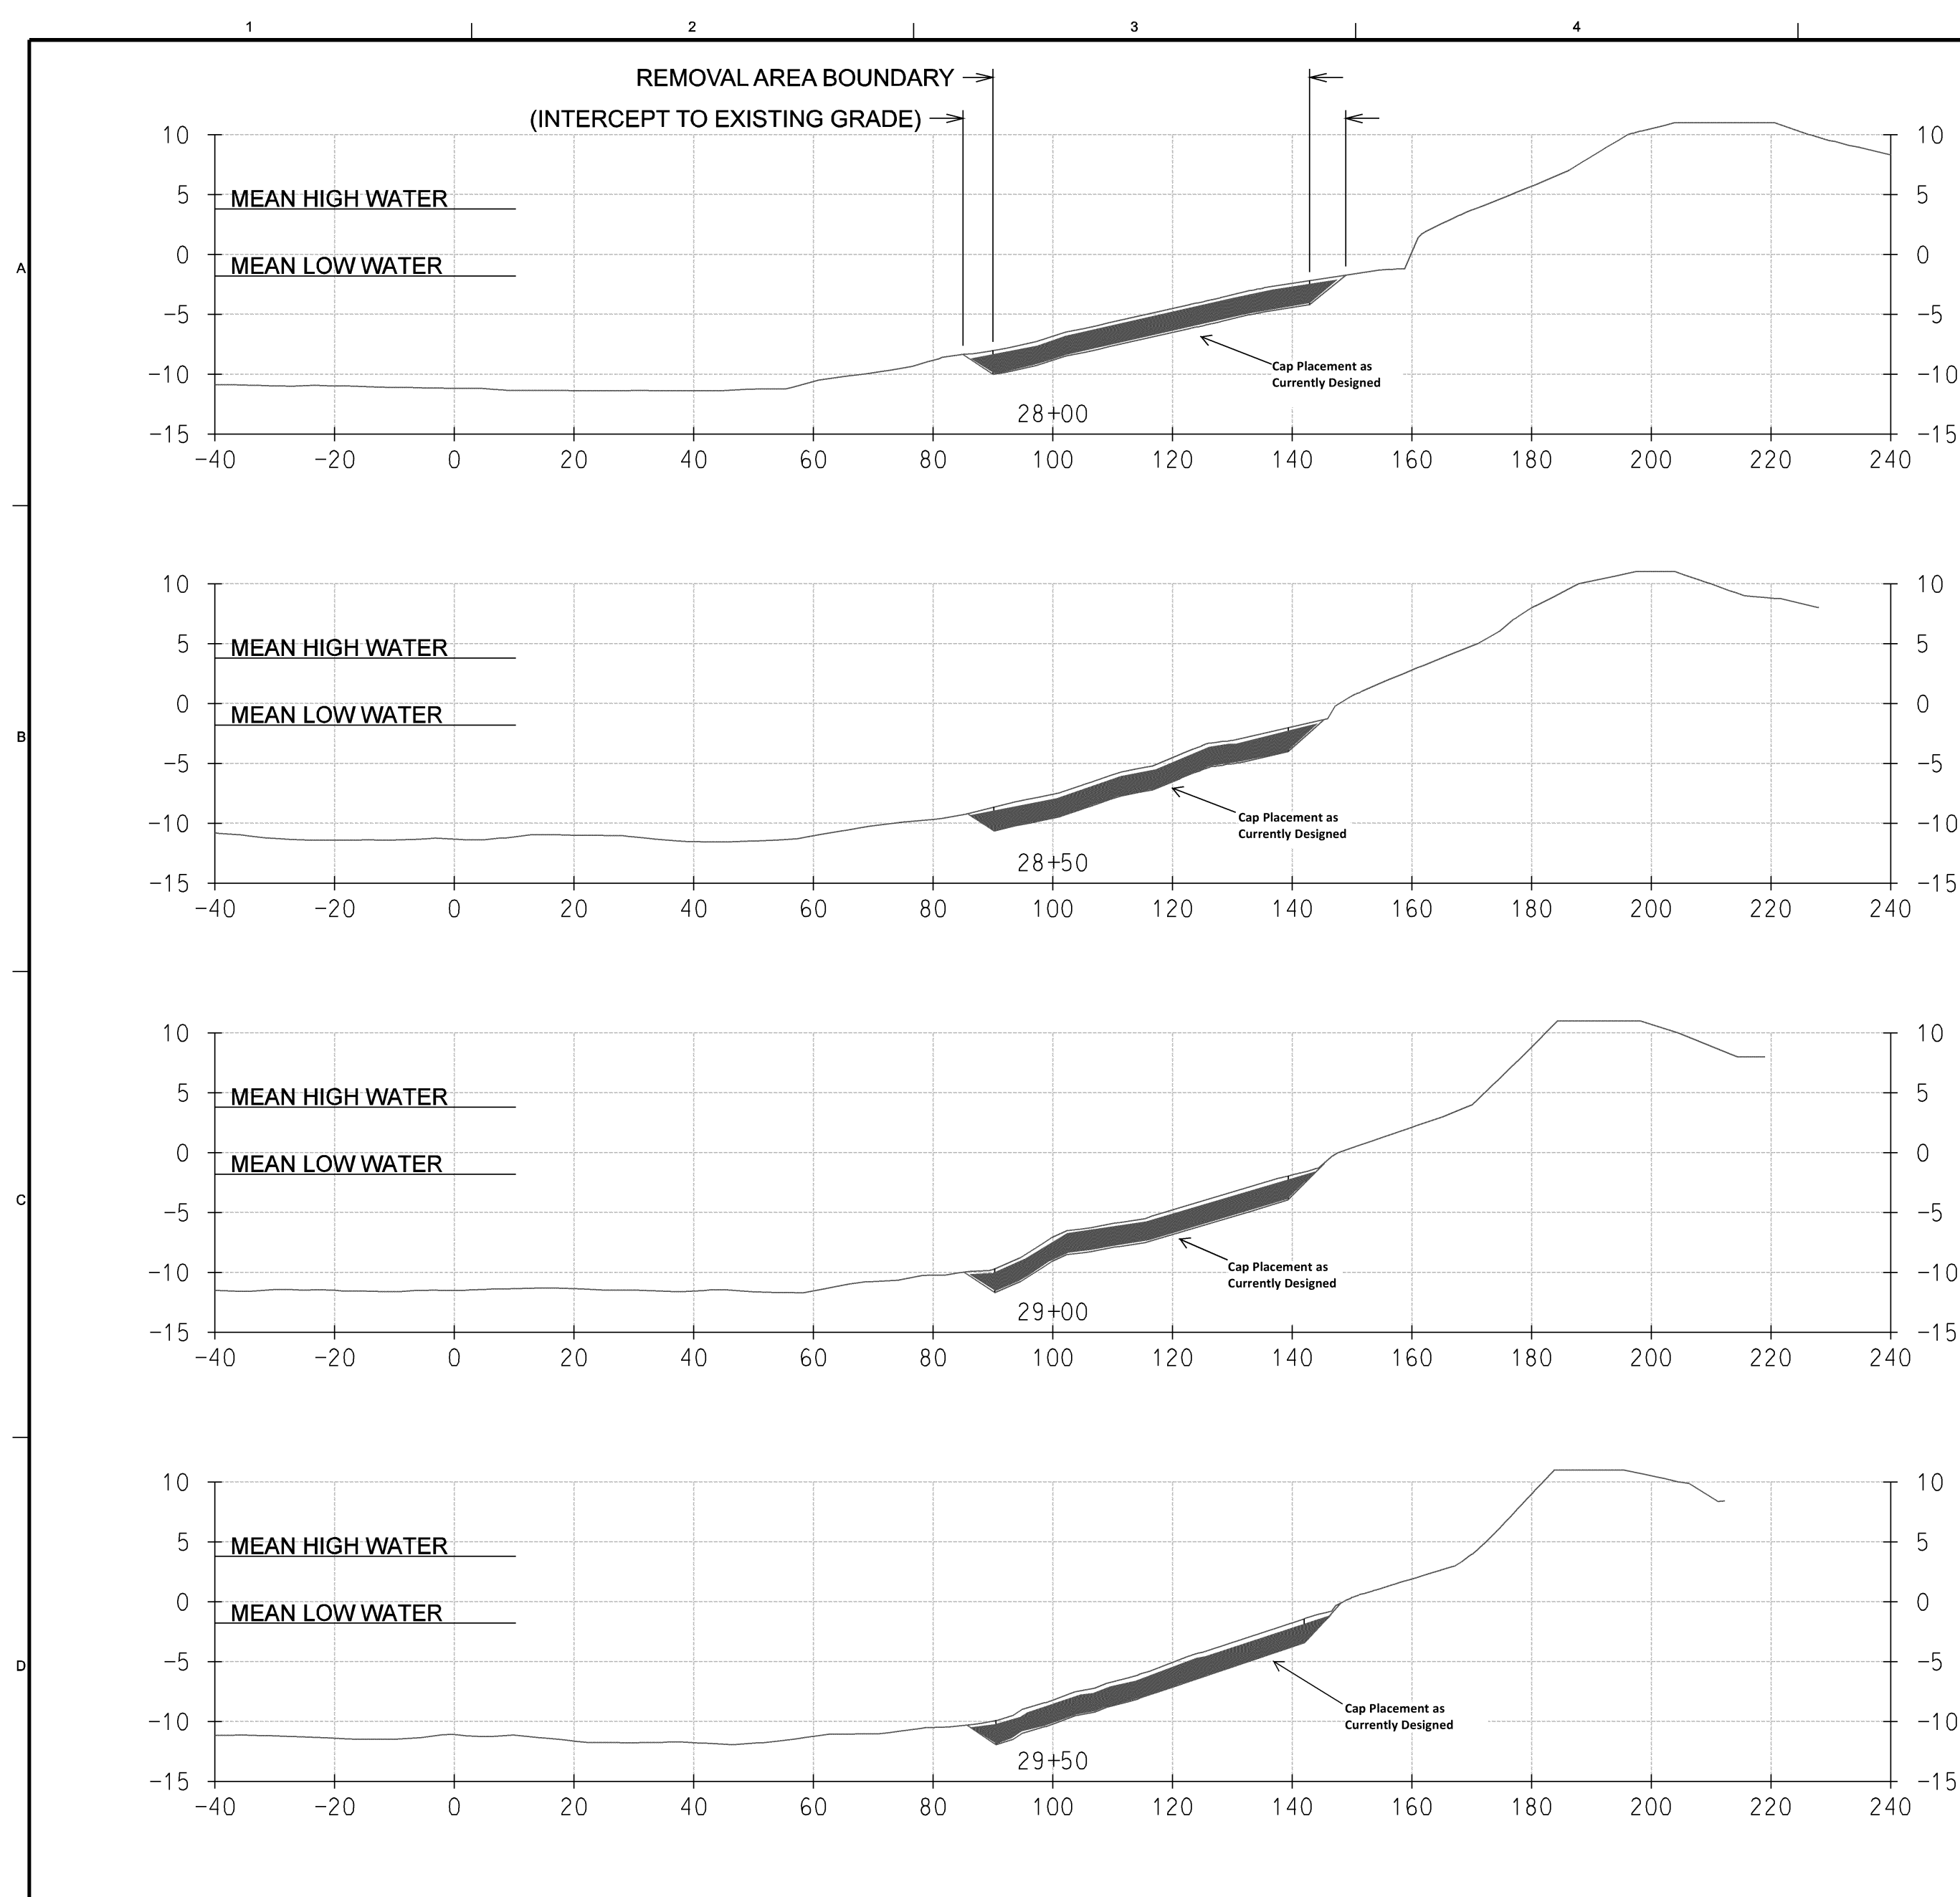
Based on these findings it was determined that the majority of the Removal Area upriver of Station 29+50 will likely not be dredgeable because the steep slope is armored with rock. The rock armor appears to have been placed to prevent erosion of the steep shoreline and was found to extend from the shoreline to the toe of the slope. Significant soft sediment is not present along the armored slope and attempting to remove soft sediment from either the armored slope or at the toe of the slope could impact the integrity of the rock armor and destabilize the bank. The impacted area specific to Cut 10, with associated cross-sections, is provided as Attachment #2.

In order to prevent destabilizing the armored steep slope, it is recommended that the design be revised to eliminate dredging on the steep slope and that no dredging shall occur closer than 10 foot from the toe of the slope. The standard RM 10.9 cap will be placed from the toe of the slope to the edge of the navigation channel as well as areas that are not dredged and do not have a slope greater than 3H:1V (Station 29+50 to Station 30+50).
